## 2<sup>nd</sup> Joint Monitoring Visit Report

Submitted to:  
**Human Relief Foundation-HRF**

Prepared and Submitted by:  
**YPSA (Young Power in Social Action) and Global Unnayan Seba Sangstha (GUSS)**

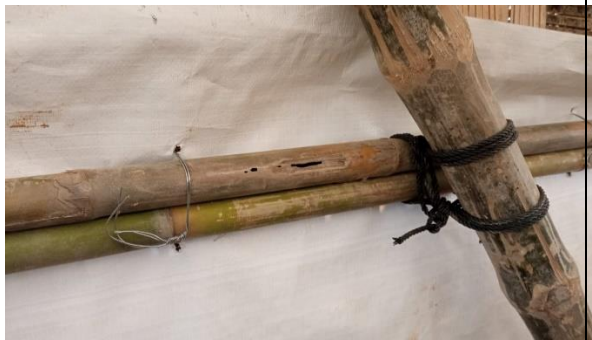
**1) Sub-standard Muli bamboo use:** Joint Monitoring visit team observe that in some three partner's shelters some sub-standard muli bamboo has been used.

Insect infected Muli Bamboo

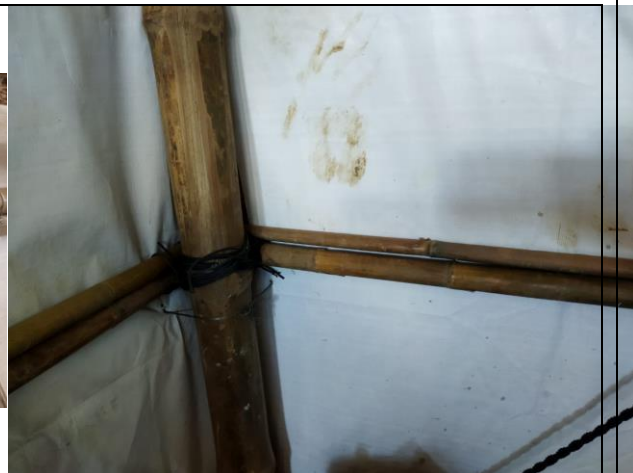
Sub-Standard Muli Bamboo

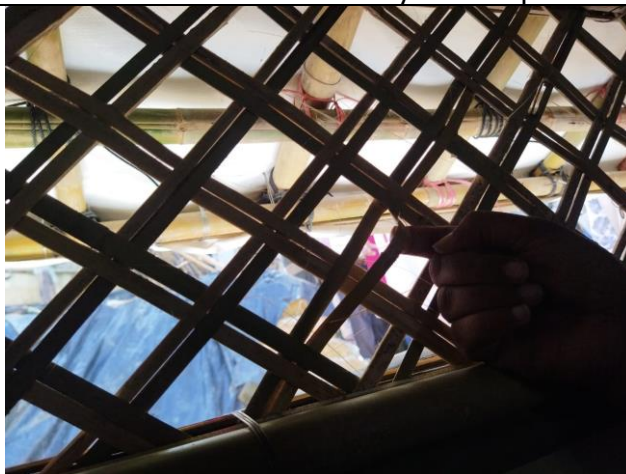
**2) Below Standard or thin Gerenja:** Basically, we use gereja for proper ventilation. it is essential for a shelter. If we can't ensure proper measurement and standard genenja then beneficiaries faced some security related problems.

n Gerenja

Thi

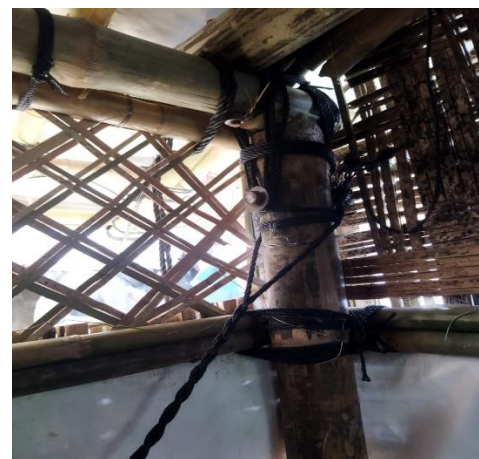
Bad finishing Gerenja

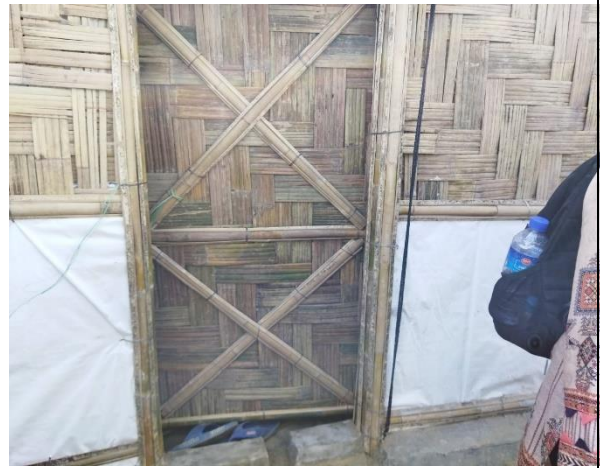
**4) Branding Tarpaulin Setup:** We saw in some shelters the wrong set up of branding tarpaulin and roof tarpaulin was not properly adjusted.

Fence Branding tarpaulin wrong setting

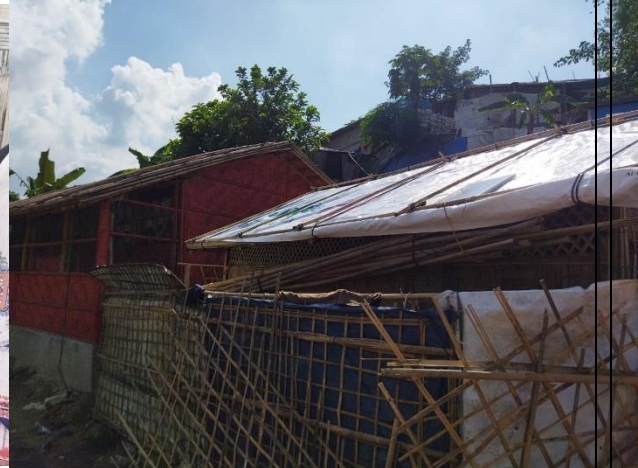
Roof tarpaulin wrong setting

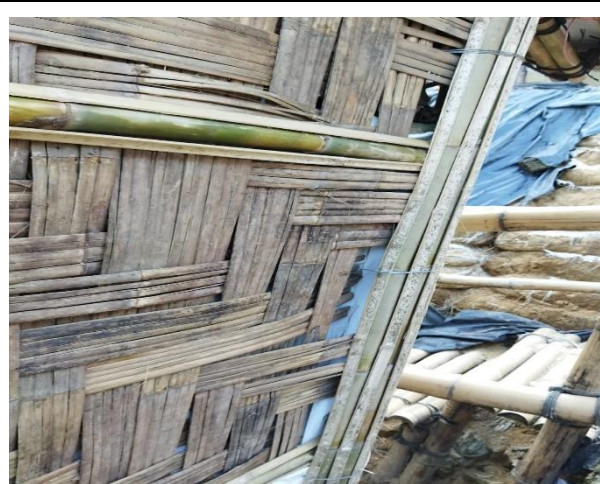
**5) Shelter and Mua low quality finishing and tie:** We noticed during the visit that the finishing work of some shelters was not done well. Such as:

Shelter Low Quality Finishing

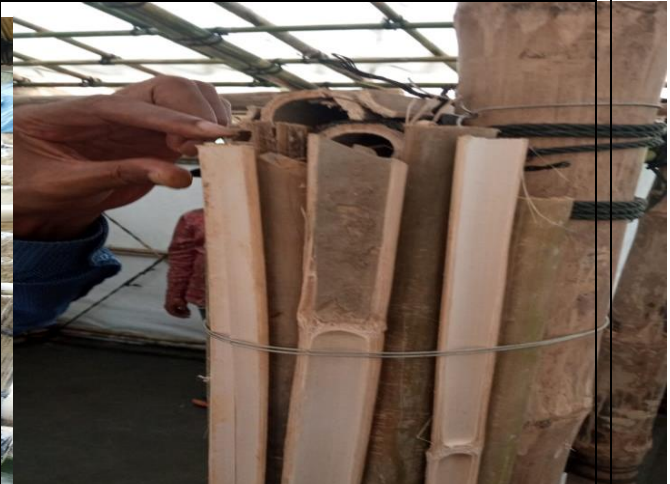
Low quality Mua Finishing

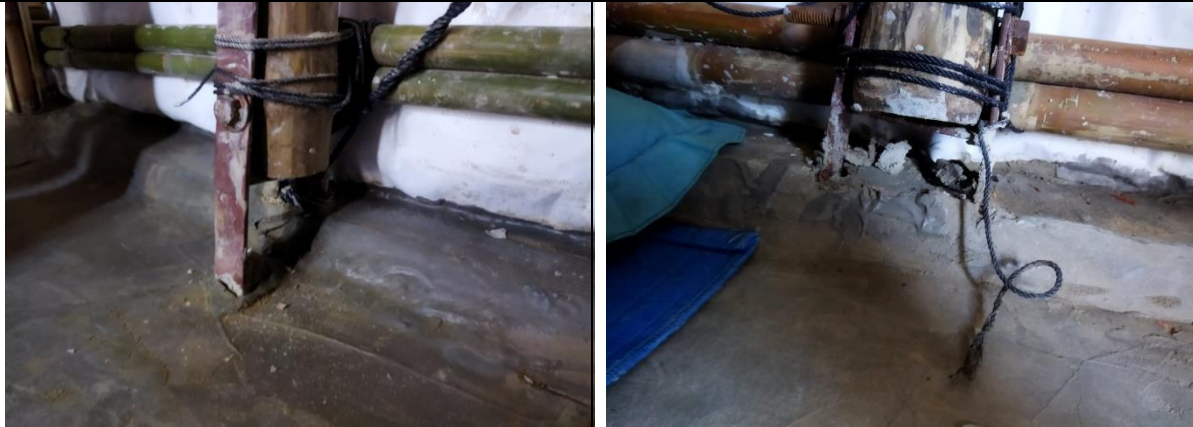
**6) Excess gap between Borak and floor:** The distance of the metal footing from the floor was supposed to be two inches, the below mentioned picture shows that the distance of the metal footing from the floor was more than four inches.

Excess gap between Boark and floor

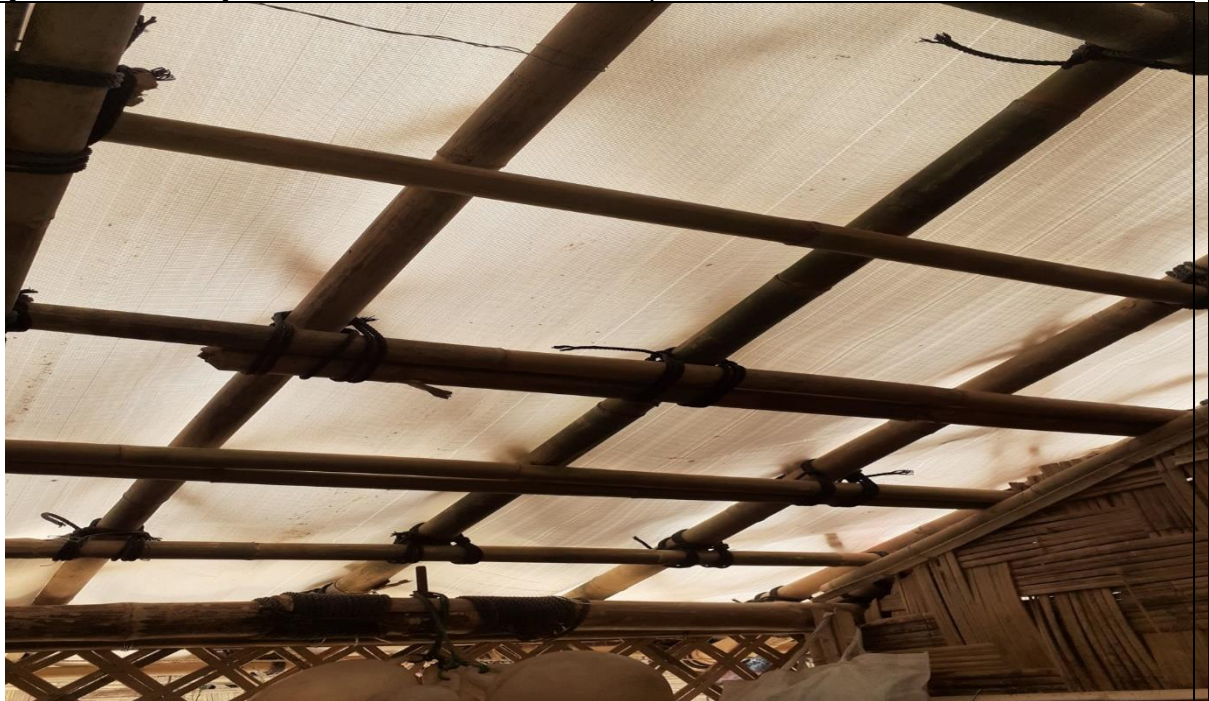
**7) No tie in Roopa:** There were no tie in the Roopa of some shelter.

No tie in Roopa

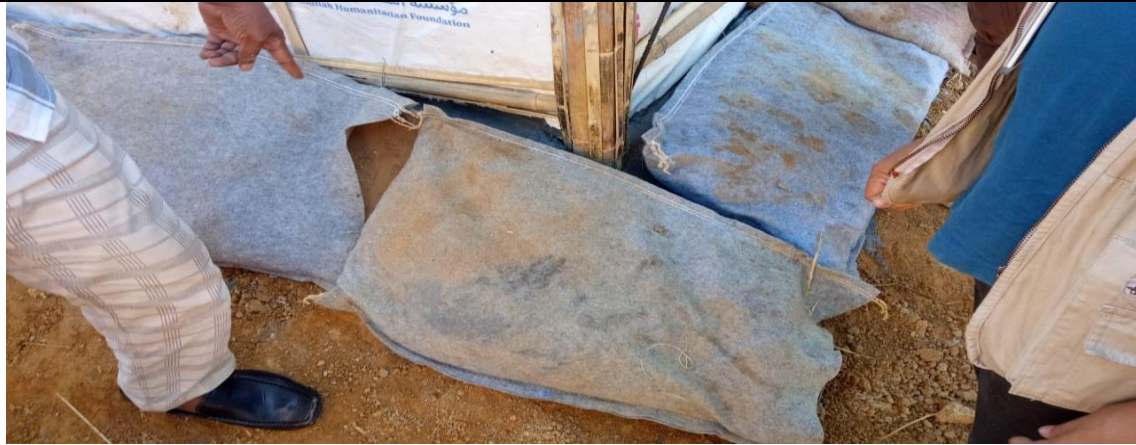
**8) Geo-Bag full of Mud & setting:** In our non-tendering work it is supposed to use filling sand in geo-bags, but some vendors use mud. So, the purpose for which the geo-bag is being given will not be achieved due to the use of soil. On the other hand due to improper settings, the beneficiaries may move these elsewhere and risk theft.

Ge

o bag improper settings

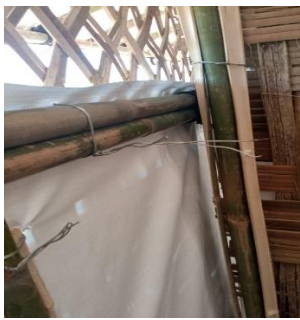
**9) Construction Harm:** we found some harm in some shelter which may have caused a serious accident. Also found some protection related findings like windows are not properly settings.

Do not cut off excess GI ware

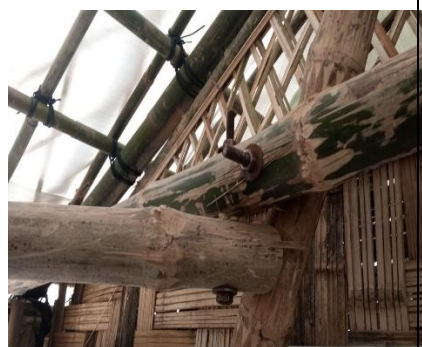
Nut vault risky direction

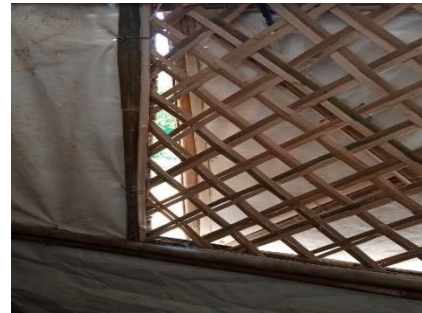
Window wrong setting

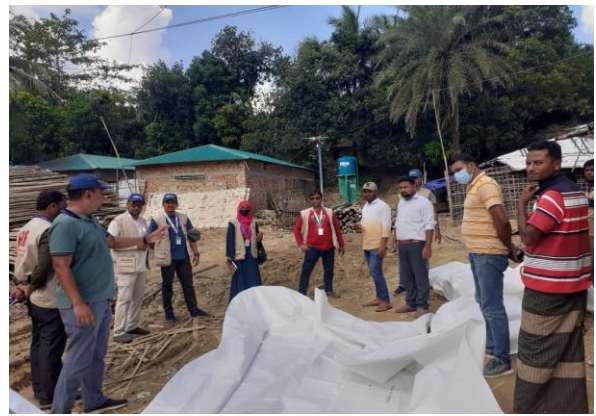
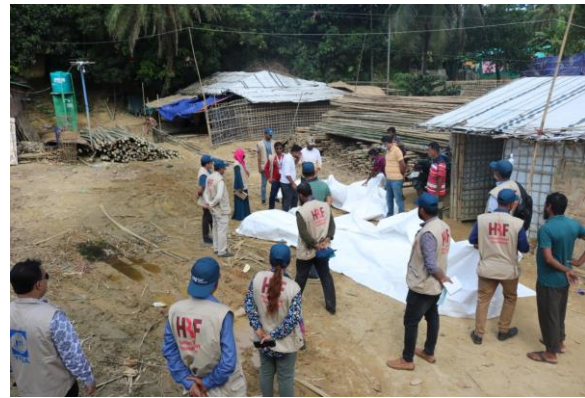
A joint monitoring team checked the quality of tarpaulin in the vendor's warehouse. The visit team found 260 sft branding and non-branding tarpaulin weight were above 4.5 kg in some cases it varied from 50gm to 80gm. Also, the visit team learned that the density of tarpaulin increases or decreases e.g. the forepart of the tarpaulin is usually thick but in the middle, it becomes thinner during the production of tarpaulin in the machine. That is why the visit team found after 120 feet tarpaulin density in a roll decreased a little bit.

Tarpaulin Checking by visit team

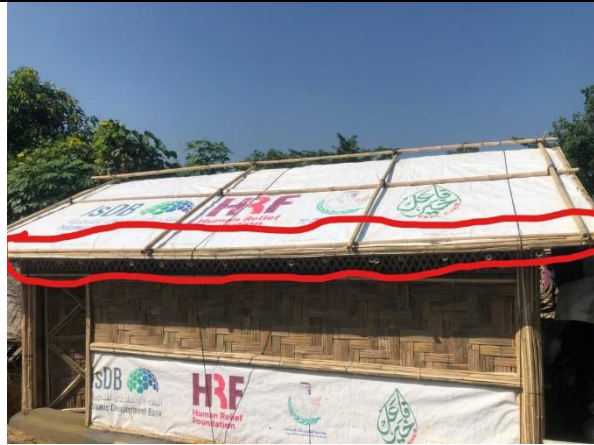
- If we setting up roof tarpaulin cover mua, it saves shelter from rain water damage.

Wrong roof tarpaulin set with Mua
