Third Joint Monitoring Visit Report

GUSS (Global Unnayan Seba Sangstha)

Shelter and WASH assistance project is being executed at FDMN camps and host community level by three implementing partners YPSA, EKATA and GUSS which financial & technically supported by HRF. The Joint Monitoring Visit was conducted on 16 November 2021 with the three implementing partners of HRF. Third joint monitoring visit was scheduled on 16 November after the second joint monitoring visit by the consent of HRF and all implementing partners and YPSA was given responsibility to lead the visit and other technical guidance. As per plan 3rd Joint Monitoring Visit was held on 16 November 2021 at project implementing sites of FDMN camps. Head of programs, shelter engineer of HRF, GUSS Chief Executive officer, YPSA Head of Rohingya Response and EKATA Program Director took part in this Joint Monitoring Visit event. Apart from this, project responsible seniors' persons from YPSA, GUSS and EKATA also participated in this event. Firstly, a short orientation given by Chief Executive Officer of GUSS to all participants. He emphasized the purpose, effectiveness and importance of this joint visit. As discussion with all

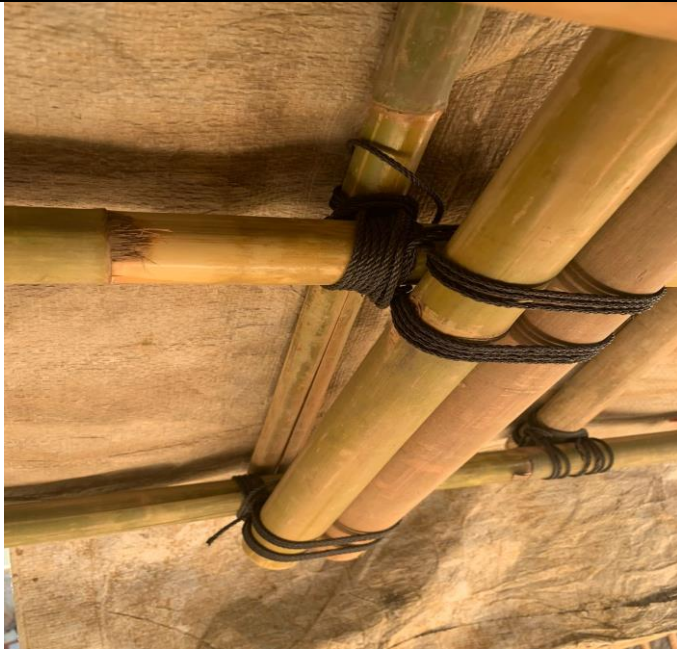
1) Immature Muli bamboo used: Joint Monitoring visit team observed that immature, insect biting and less diameter Moli bamboos have been used in some shelters.

Immature muli bamboo used in the roof

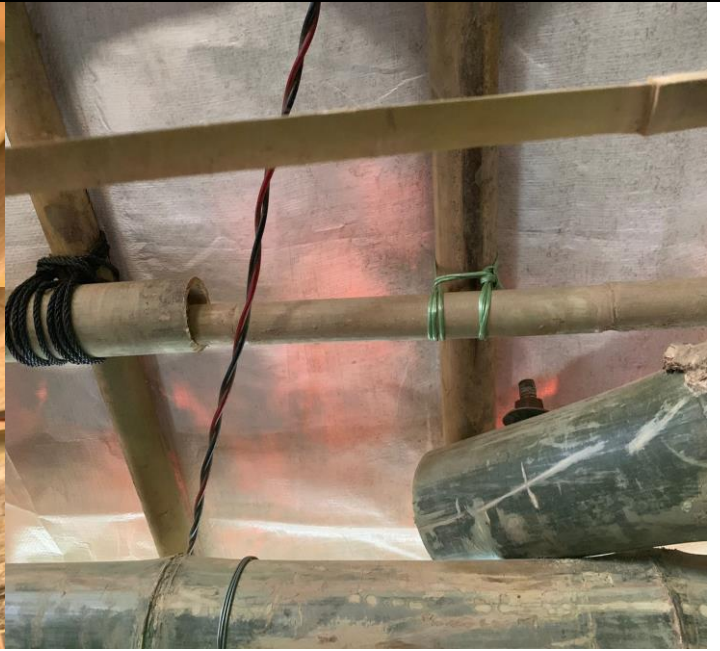
Comparatively thin and insect biting muli used.

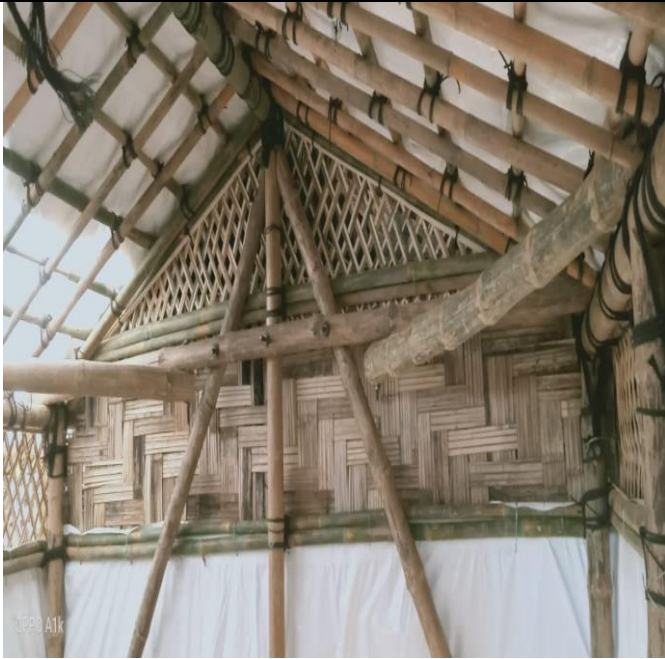
2. Thin Borak/below standard Borak used in MTS: Doubtlessly mature and good criteria Borak bamboos are supposed to be used in midterm shelter construction on which longevity of the shelters depend on but during joint monitoring visit we have still observed that in some places non-criteria boraks are being used.

Less standard borak used in MTS construction

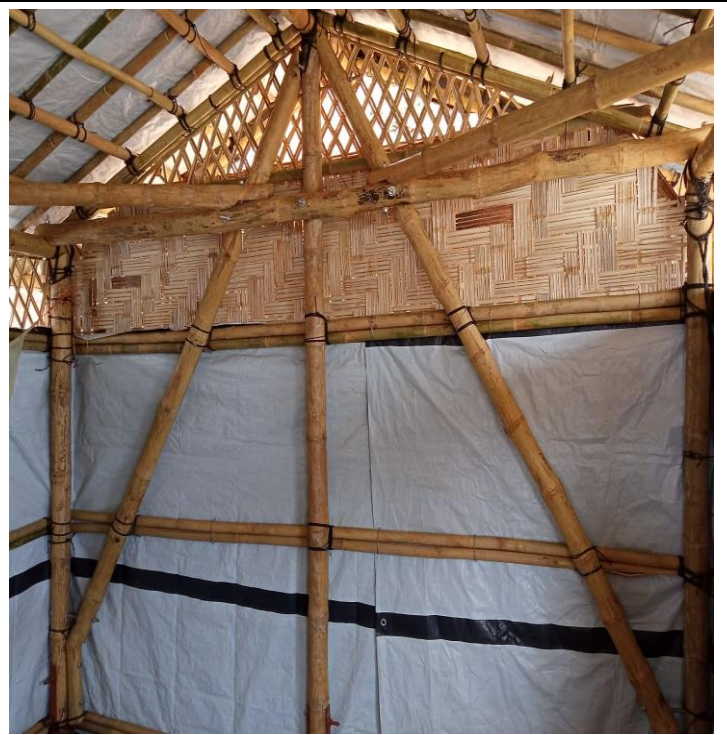
3. Shelter corner finishing and rope used are not in proper way: The corner of the shelter is supposed to be adjusted with the fence properly but some labours don't have any clear idea how to fit this corner and still rope is being tied in wrong methodologically.

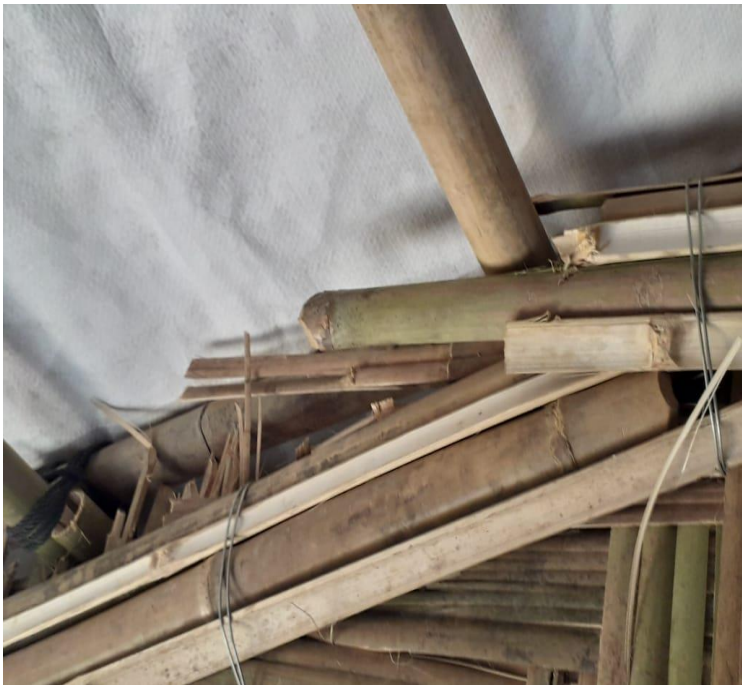
Shelter Low Quality Finishing

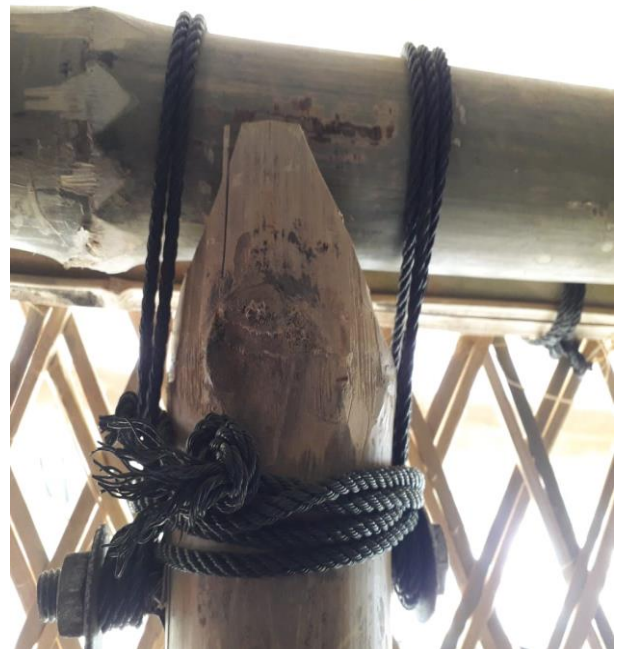
Rope tied is in wrong methodologically

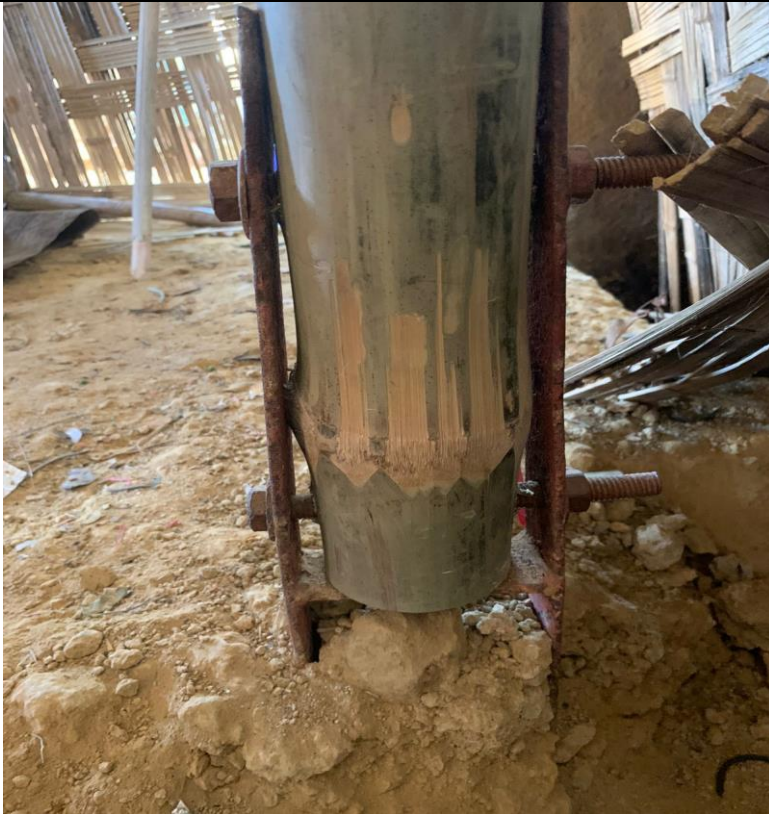
4) No gap between floor and metal footing and sometimes metal putting set up in wrong position: Some gap should be remained between bamboo set up and floor. In some places there is wrong set up of bamboo and metal putting and there is a possibility of spoil of the bamboo due to floor touch. Apart from this in some

No gap between Boark and floor

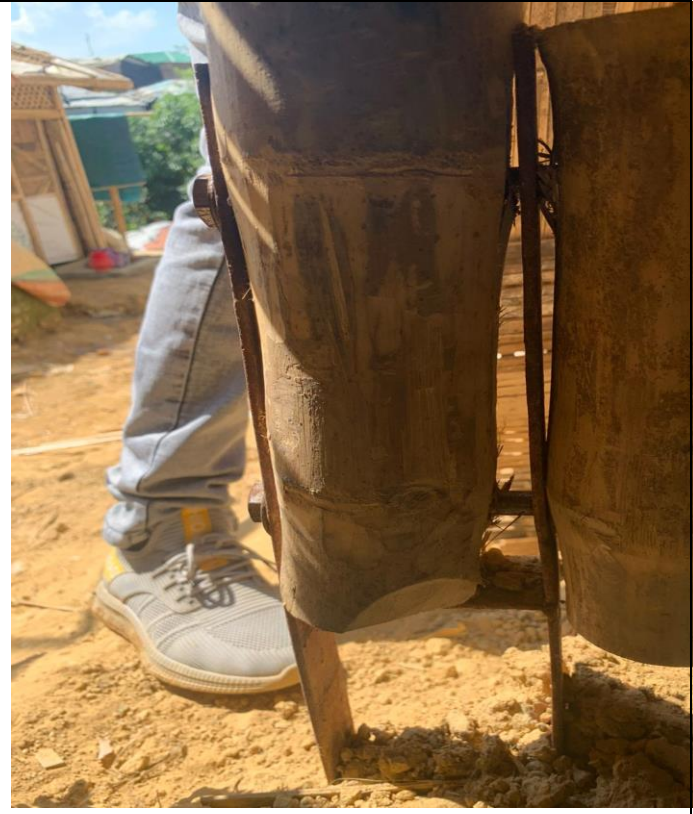
places metal putting has been set up through the one side of the Borak bamboo but it is supposed to be through the middle of the Borak bamboo.

Wrong set of metal putting with Borak bamboo

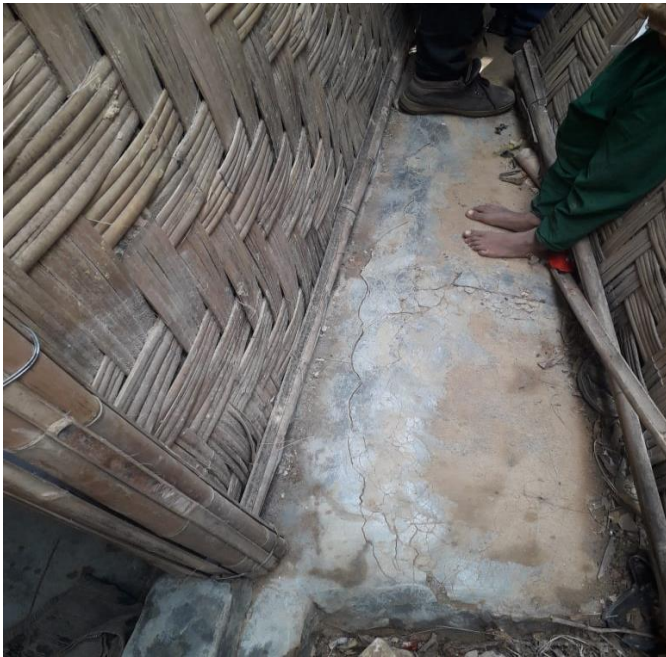
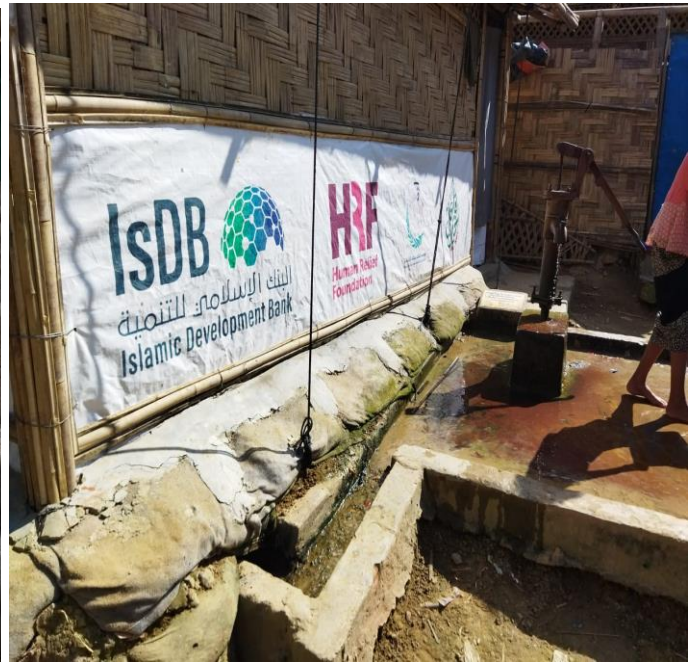
5) Cement plaster on GEO bags washed away: Cement plaster has been put on the GEO bags which has not been adjusted properly and cement plaster is washed away gradually and a lot of holes were found at the top layer of the cement plaster and GEO bags.

Cement plaster is not adjusted on GEO bags and GEO bags questionable setting around the plinth

- GEO bags set up not in proper way. If cement plaster is given at surface, plaster is washed way quickly. So regarding this issue, quick decision should be revealed to the partners.

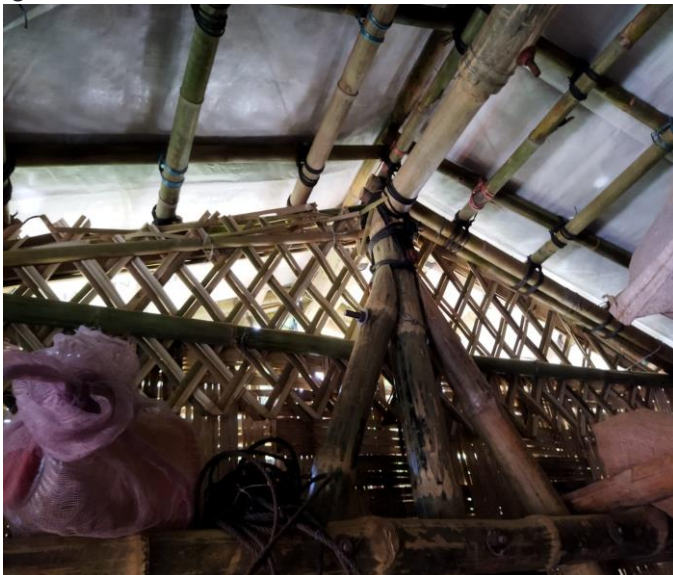
During joint monitoring visit in some places, it was observed that there was no renovation and well finishing of the using Muli, borak bamboos and Gerenja . On the other hand GEO bags have been put in wrong position surrounding area of the plinth and possibility to displaced / missing from the plinth side. Gerenja finishing is not right. And the hole is more than two inches, which is questioning the privacy of the beneficiaries. In spite of having frequent monitoring and supervision, it is happening in some places. Sometimes the engaged labours ignore this issue.

Gerenja Bad Finishing

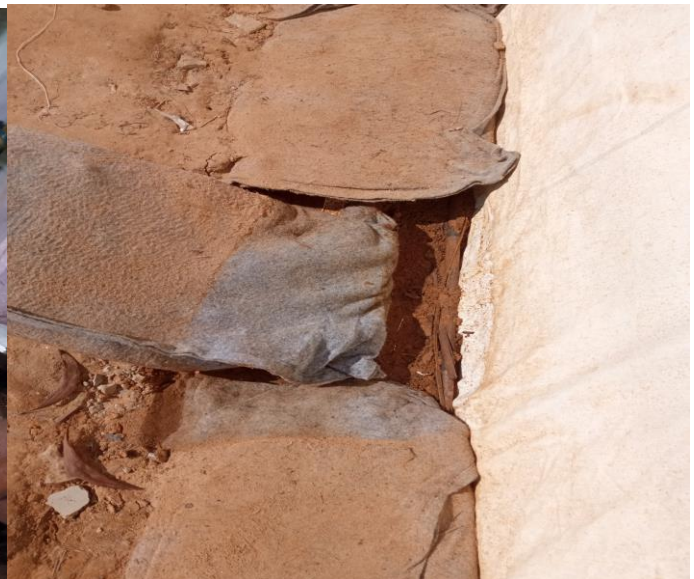
GEO bag set up in wrong methodologically

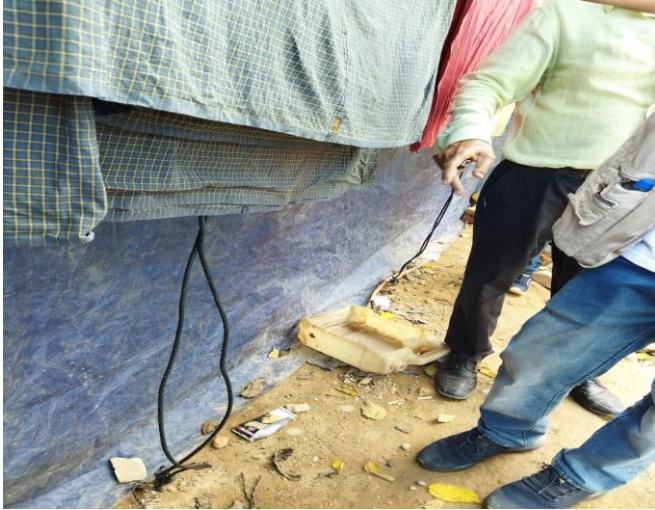
9. Loose tie down Kit: Tie down kit keeps the shelter strong and safety during heavy wind/storm. But during visit we saw that tie down kit set was in loose position which can't protect the shelter during emergency period.

Loose tie down kit and not adjusted with MTS

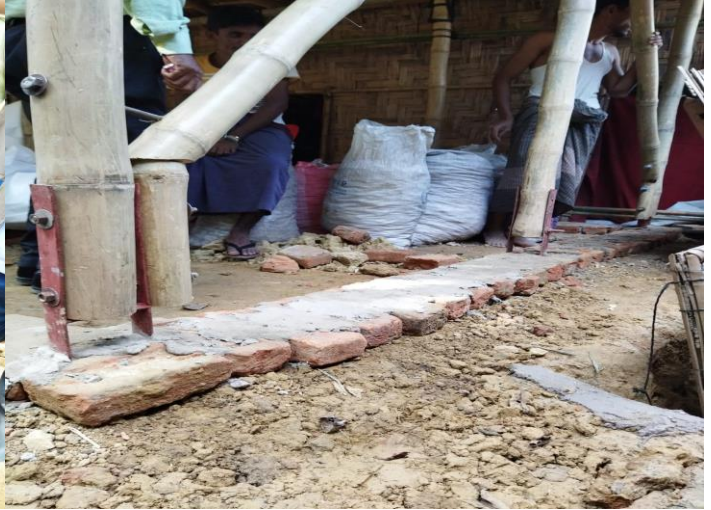
11. Brick Work: According to the RRRC and Shelter BOQ permanent structure are strongly prohibited but in the mentioned picture it is seen that brick work is being done which can cause various complications later to various authorities.

Bricks used in MTS shelter

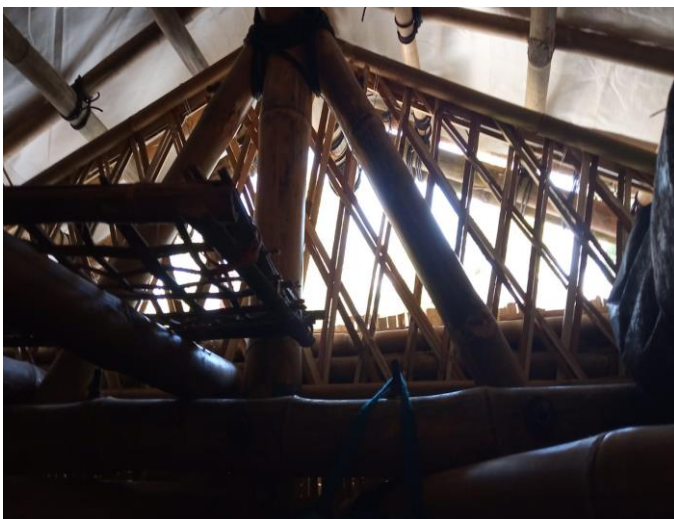
Granja's gap is too large

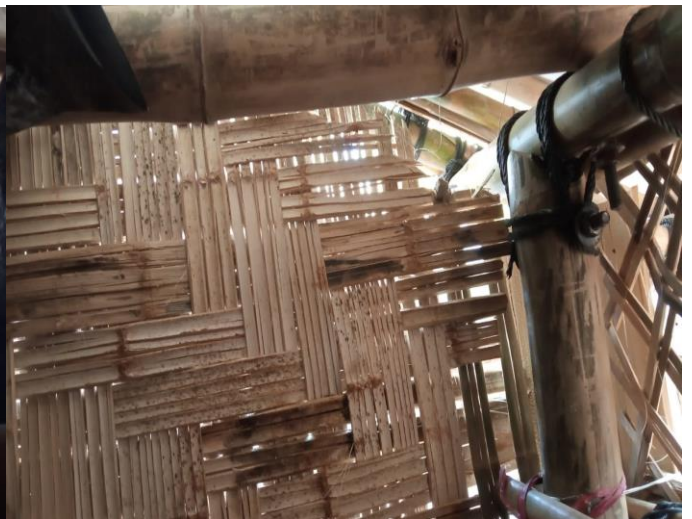
Not accurate finishing of shelter's corne

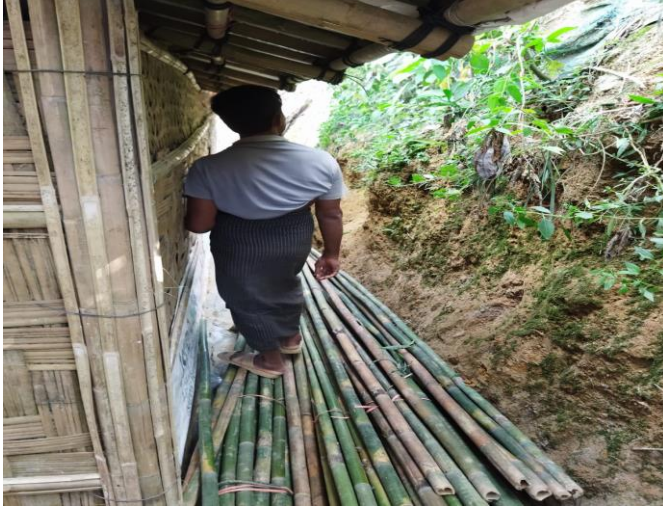
10. Shelter construction under landslide area: Due to the lack of slope protection, the shelter is in a very risky condition. Especially during the rainy season, the risk of landslides is the highest.

MTS construction under risk of land slide

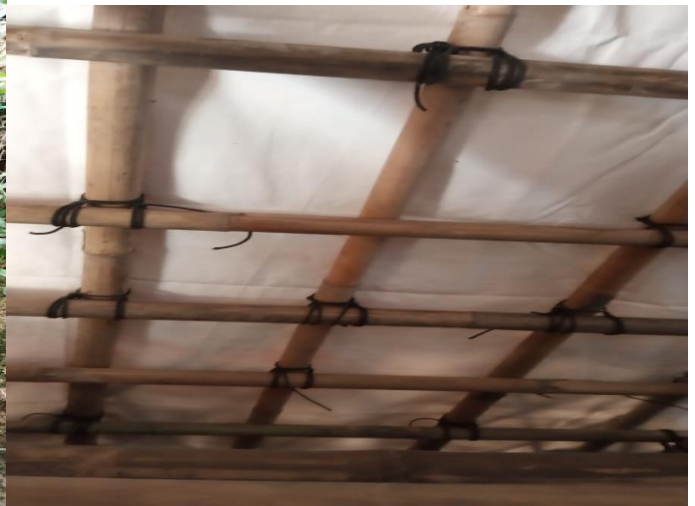
Not found tie of plastic rope

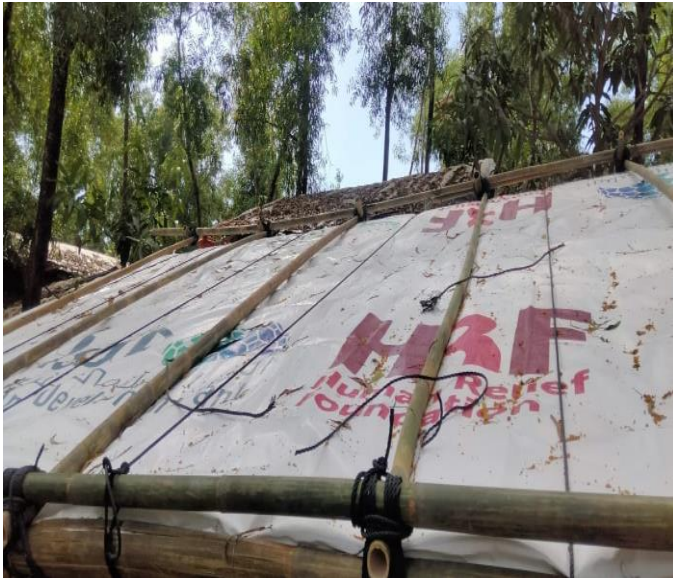
7. Wrongly set of branding tarpaulin: Joint Monitoring Team found that branding tarpaulin set up was in wrong position and logo was not visible and roof tarpaulin was not properly adjusted.

Wrongly set of branding tarpaulin

- The budget of bathing facility is enough. So, all partners should start construction quickly.
- In camp 8E new branding tarpaulins have to be set up and Branding tarpaulin is smaller than the shelter size. If there is any shortage of branding tarpaulin, it must be reported to HRF and HRF will provide the shortage tarpaulin.
- The number of host community shelter will reduce because of revise budget and concerning this issue HRF will communicate with DC office along with all program managers. If we fail to start the host community shelter, implementing partners have to face with big trouble which will spoil the reputation of the organization. So this problem needs to be solved immediately.
- In camp 8E for solar, fire extinguisher and new tarpaulin set up no need to make new beneficiary list only muster roll has to be prepared for proper document.

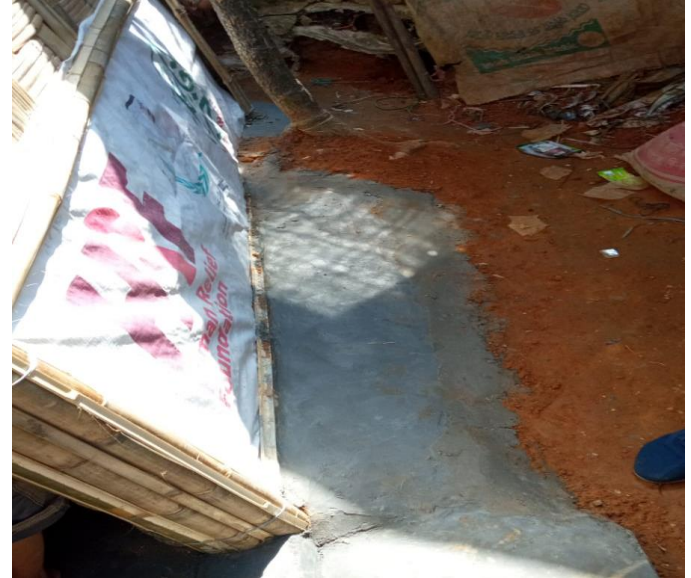
GEO bag not found in the outside plinth

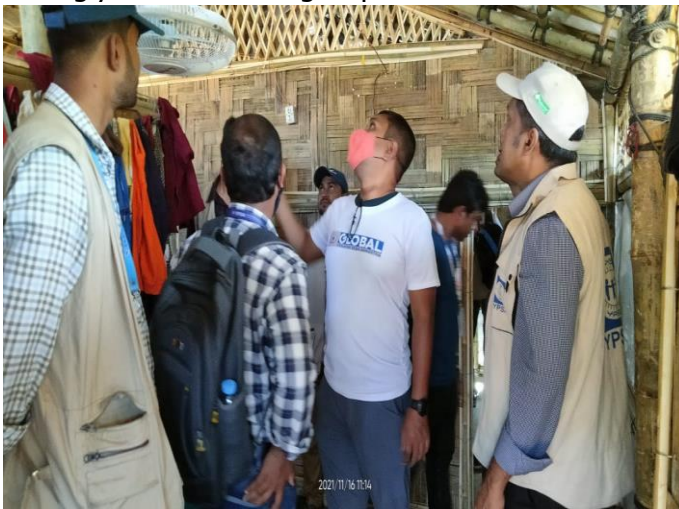
In partition fence MOA is not found in one shelter and JMT is pointing out this problem.

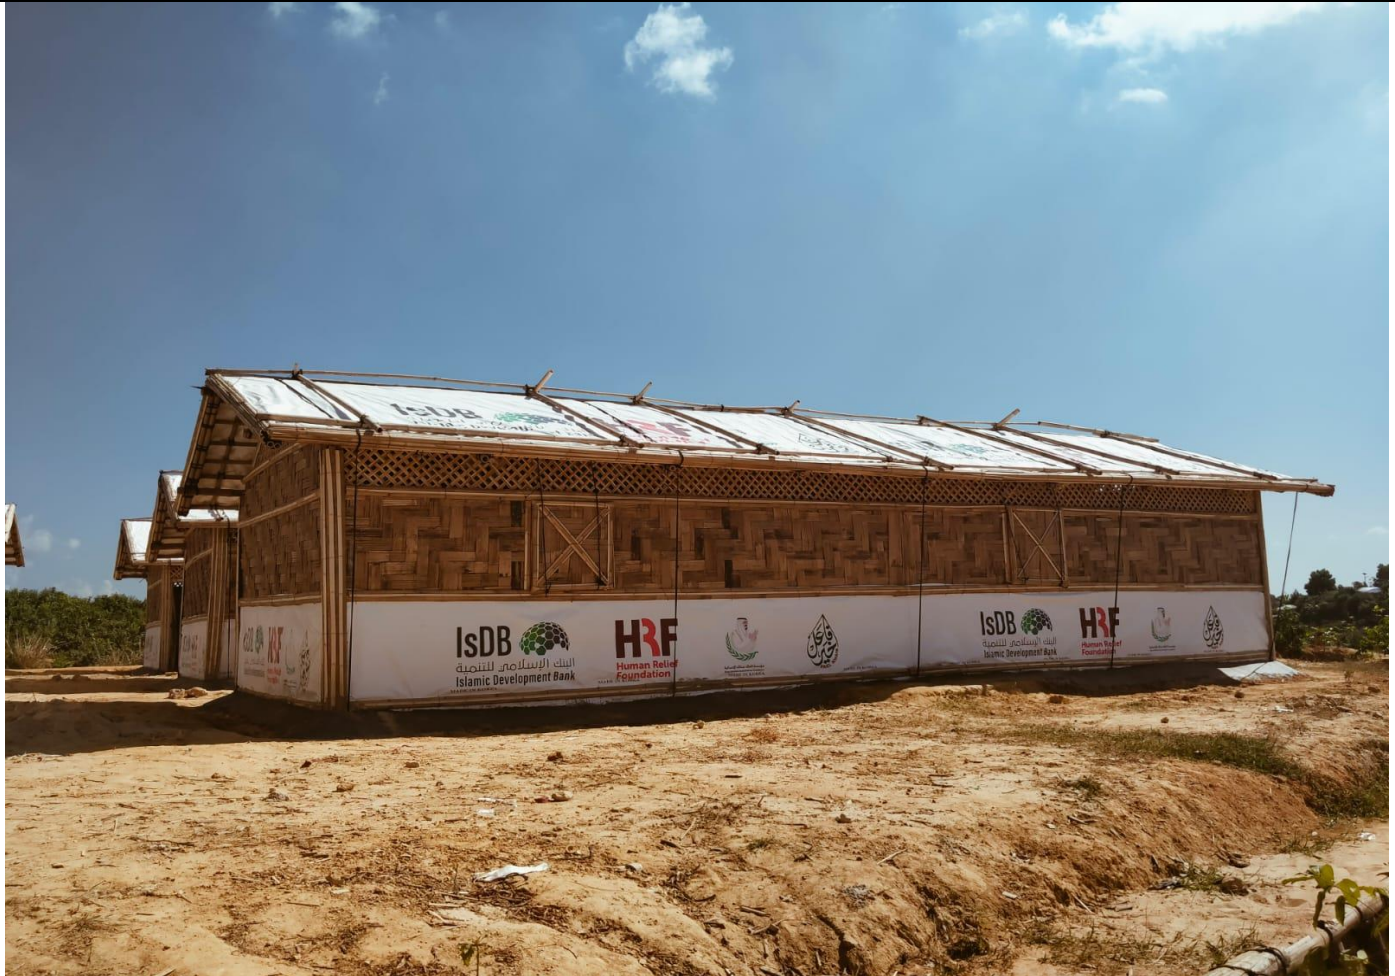
Some newly constructed cluster shelters in FDMN camps
