## 2<sup>nd</sup> Joint Monitoring Visit Report

Submitted to:  
**Human Relief Foundation-HRF**

Prepared and Submitted by:  
**YPSA (Young Power in Social Action) and Global Unnayan Seba Sangstha (GUSS)**

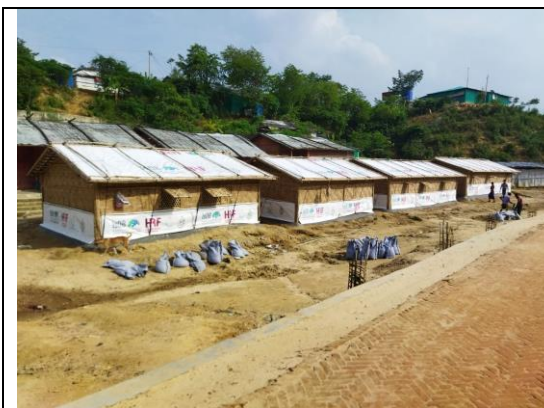
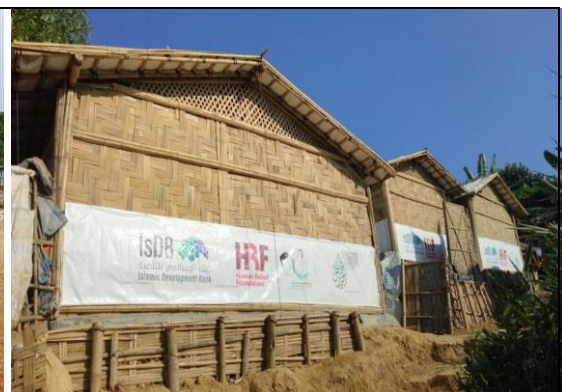
Shelters in a cluster

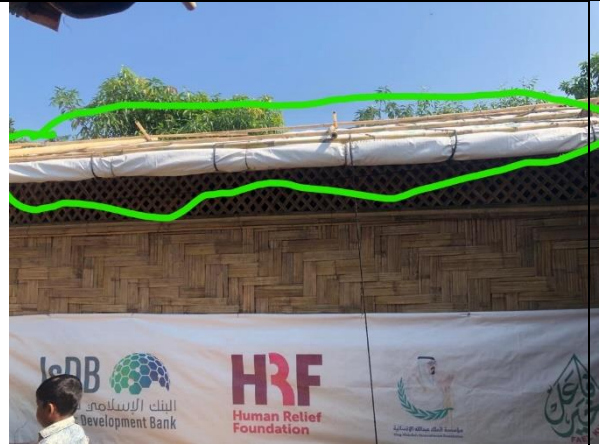
- If we setting up roof tarpaulin cover mua, it saves shelter from rain water damage.

Right roof tarpaulin set with Mua
